DEPARTMENT OF TRANSPORTATION

Quality Assurance and Source Inspection

Contract #: 04-0120F4Cty: SF/ALA Rte: 80 PM: 13.2/13.9File #: 69.28**WELDING INSPECTION REPORT****Resident Engineer:**Siegenthaler, Peter**Address:** 333 Burma Road**City:** Oakland, CA 94607**Report No:** WIR-018510**Date Inspected:** 02-Dec-2010**Project Name:** SAS Superstructure**OSM Arrival Time:** 700**Prime Contractor:** American Bridge/Fluor Enterprises, a JV**OSM Departure Time:** 1900**Contractor:** Zhenhua Port Machinery Company, Ltd (ZPMC), Changxing Island **Location:** Shanghai, China**CWI Name:** Xu tao**CWI Present:** Yes No**Inspected CWI report:** Yes No N/A**Rod Oven in Use:** Yes No N/A**Electrode to specification:** Yes No N/A**Weld Procedures Followed:** Yes No N/A**Qualified Welders:** Yes No N/A**Verified Joint Fit-up:** Yes No N/A**Approved Drawings:** Yes No N/A**Approved WPS:** Yes No N/A**Delayed / Cancelled:** Yes No N/A**Bridge No:** 34-0006**Component:** OBG Components**Summary of Items Observed:**

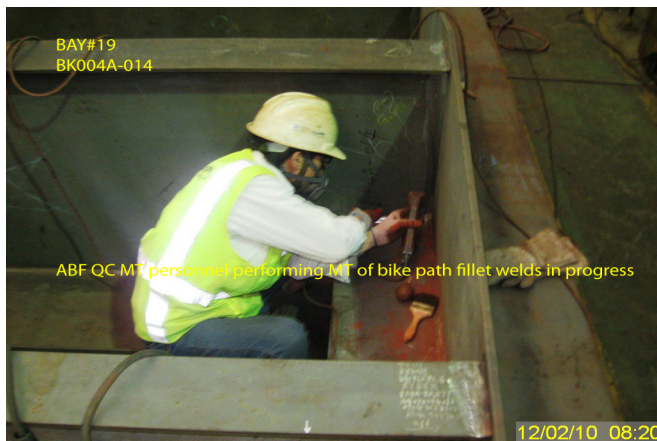
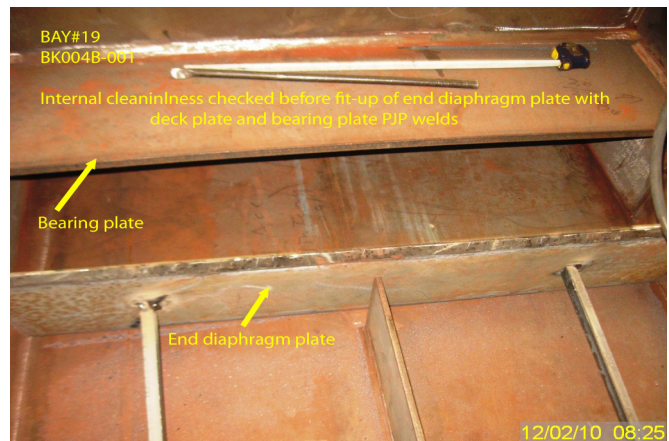
SMAW welding of repair weld is identified as 4G-021 of BK5ASD1-002 for BK005A-002. The welder is identified as 259353. ZPMC QC is identified as Mr. Guo xing hui. The welding variables recorded by QC are appeared to comply with the WPS-345-SMAW-4G-Repair and B-WR18035.

Internal cleaning of bike path BK004B-001 checked before fit-up of End diaphragm plate (PJP weld) with deck and bearing plate.

ABF QC MT personnel performing MT on bike path fillet welds, the bike path is identified as BK004A-014 in progress.
